Truck Driver Poisoned by Carbon Monoxide in Cab

REPORT #: 71-254-2024s

REPORT DATE: June 1, 2024

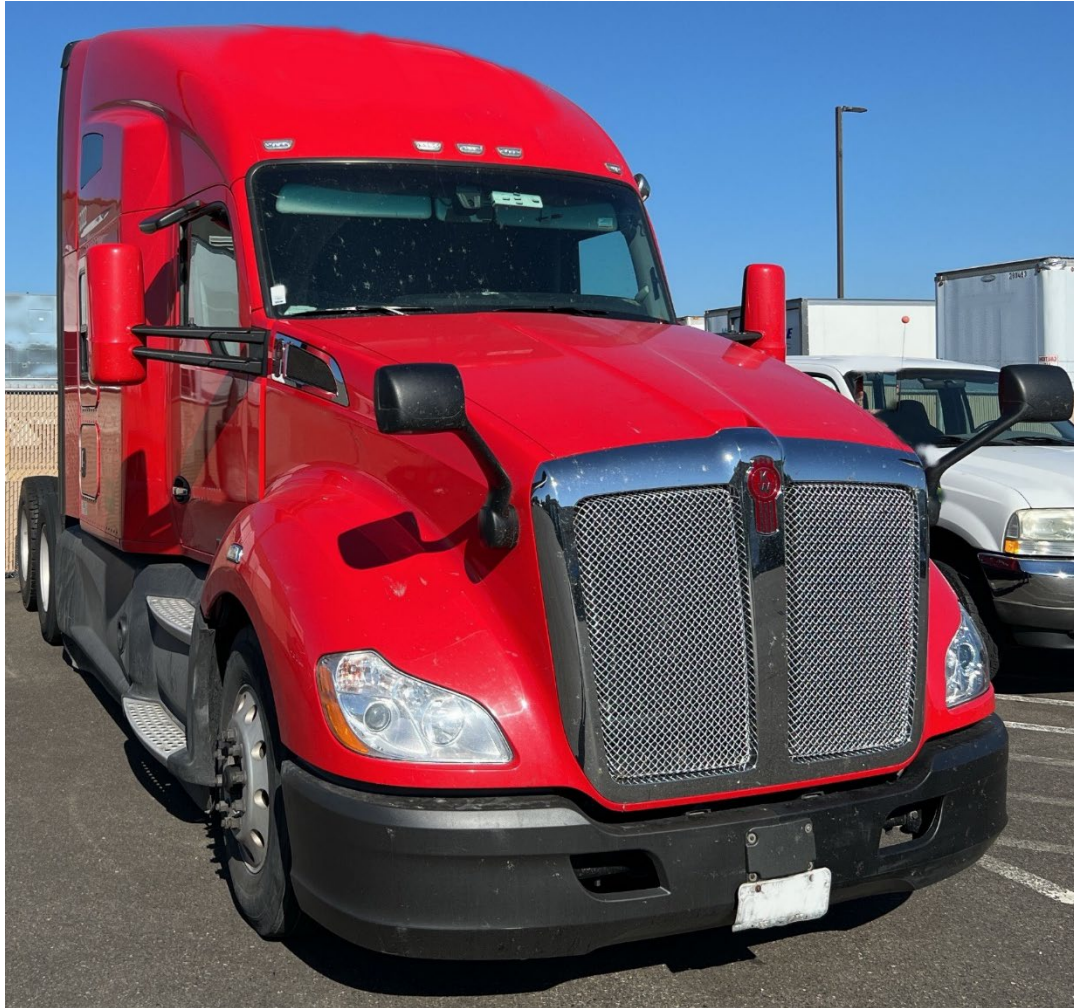
- The driver was most likely poisoned by CO from a single-burner butane cooking stove found in the truck.
- The sleeper had a bunk heater with a small diesel-powered blower motor. Air monitoring in the sleeper and near the heater's exhaust while it was running did not show any significant amount of CO.
- No exhaust leaks were detected in the truck's engine or undercarriage area.

Photo 1. Truck from incident.

- Install battery-powered CO detector alarms in truck cabs and sleeper berths. Use only detectors made for vehicles. Always follow the detector manufacturer's installation, maintenance, and safety instructions.

- Train and evaluate drivers' knowledge about CO hazards, exposure sources, prevention methods, detector alarms, poisoning symptoms, and emergency responses. Conduct periodic refresher training.
- Perform regularly scheduled preventive maintenance checks and services on engine and bunk heater exhaust systems to ensure CO leaks are detected and repaired before the truck is returned to service.

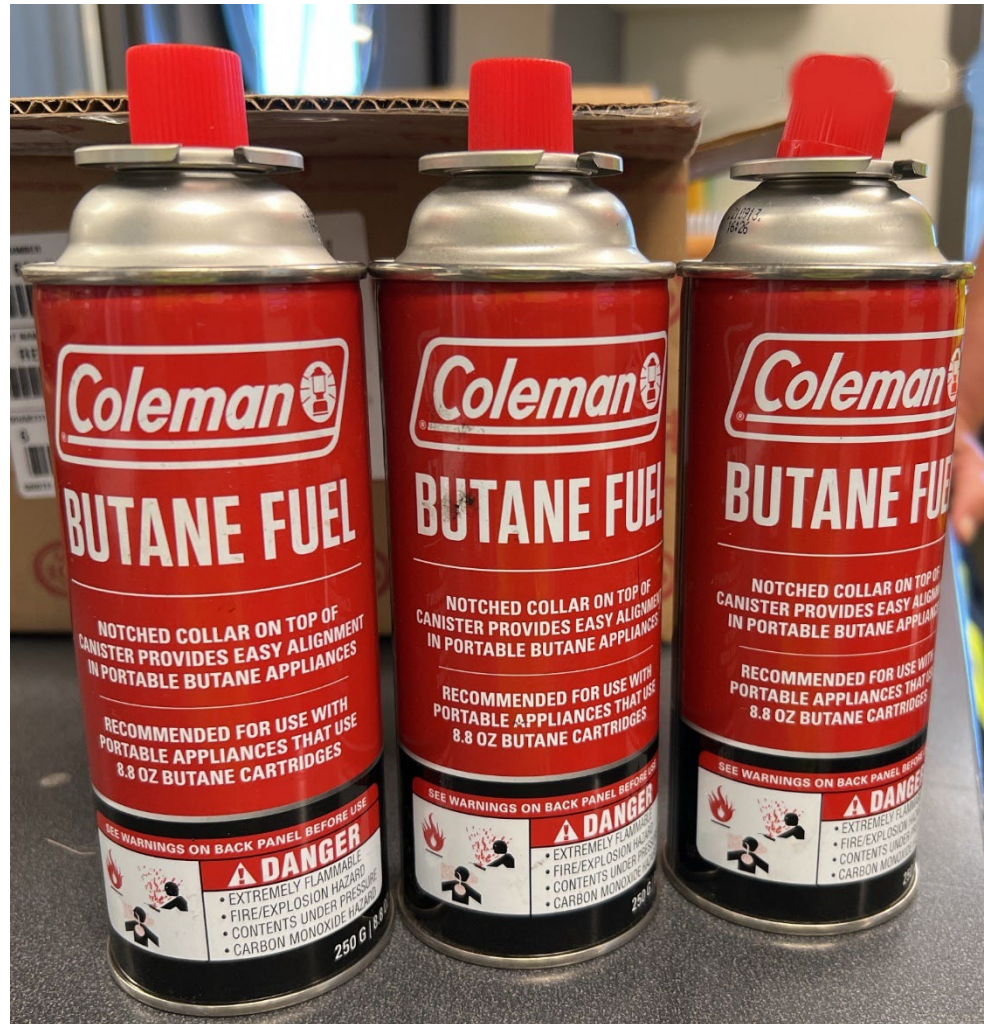
Photo 2. Butane cooking stove fuel canisters found in truck.

- Develop and enforce clearly written accident prevention program (APP) policies for CO poisoning prevention. Policies should:
 - Prohibit use of butane, propane, and other fuel-burning cooking stoves and space heaters inside cabs, sleepers, and trailers. Fuel canisters can produce CO, a colorless, odorless, and tasteless toxic gas that can quickly, and without warning, cause brain and heart damage, unconsciousness, and suffocation.

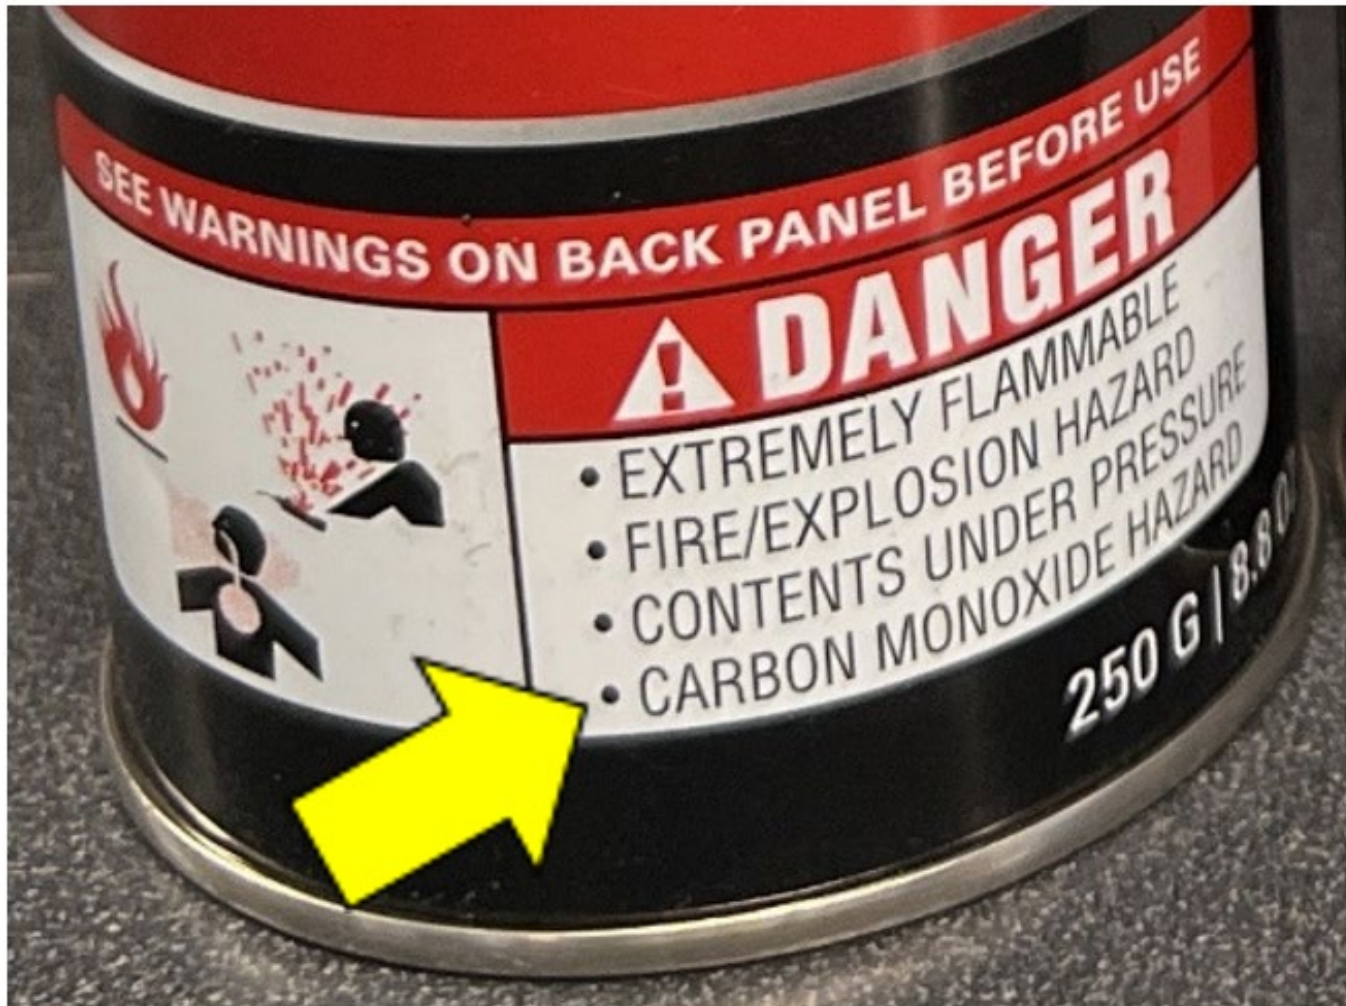
Photo 3. Carbon monoxide hazard warning on butane cooking stove canister.
